## Magnitude 6.7 NORTHRIDGE

Monday, January 17, 1994 at 12:30:55 UTC

Twenty-eight years ago, a magnitude 6.7 earthquake shook the San Fernando Valley north of Los Angeles in the early morning of January 17th. It destroyed homes, damaged hospitals and schools, triggered over 10,000 landslides, and caused sections of elevated freeways to collapse. 60 people lost their lives and nearly 9,000 were injured. While a M 6.7 quake is relatively moderate in size, it had a major impact because it was centered directly beneath a heavily populated and built-up urban region.

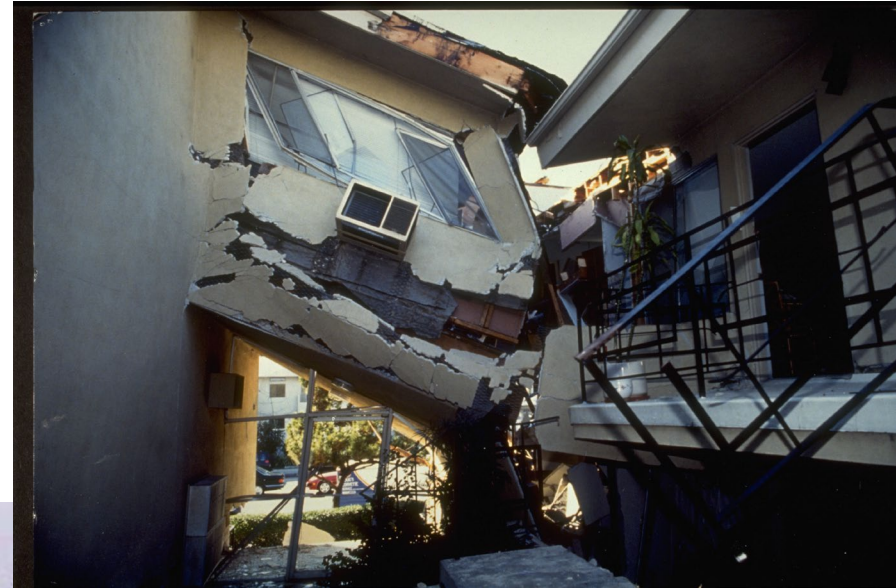
Sixteen people were killed when the Northridge Meadows apartment complex collapsed. *Image courtesy of FEMA News Photo*

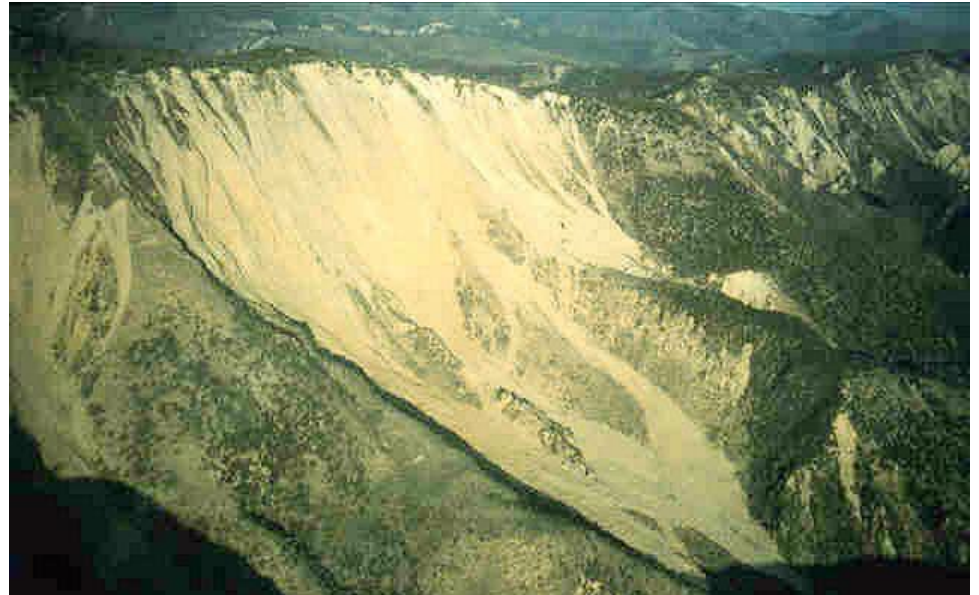
Most of the mapped landslides occurred in the nearby Santa Susana and San Gabriel Mountains (top photo), where steep slopes are common.

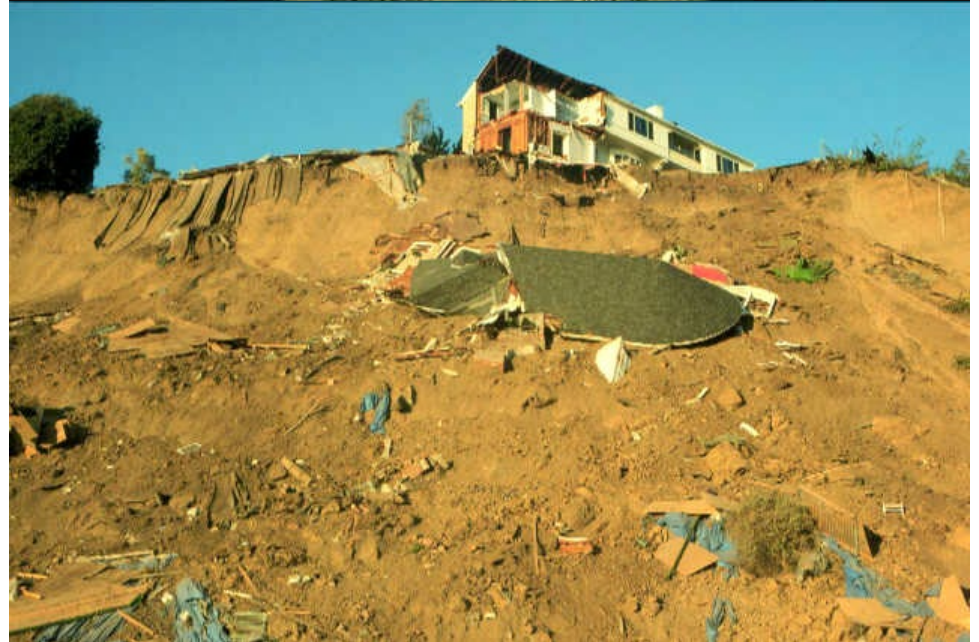
Landslides at coastal bluffs, like the one pictured near Pacific Palisades (bottom photo) damaged homes and caused some to break loose and cascade down the bluffs.

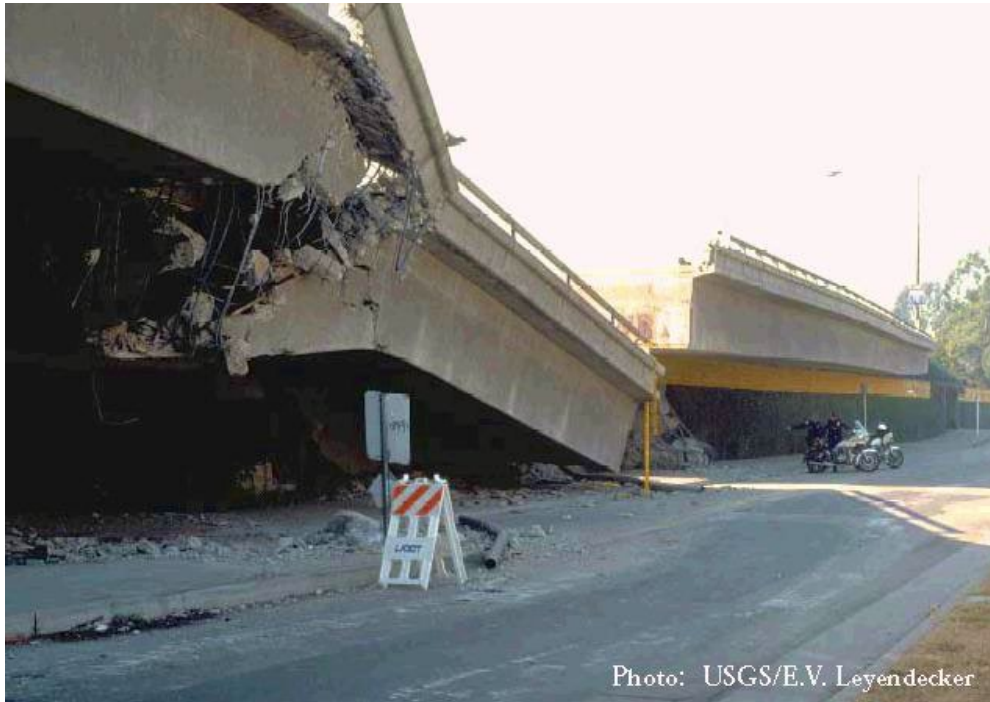
The Santa Monica Freeway (below), one of the busiest in the country, collapsed during the quake and traffic had to be rerouted for several months.

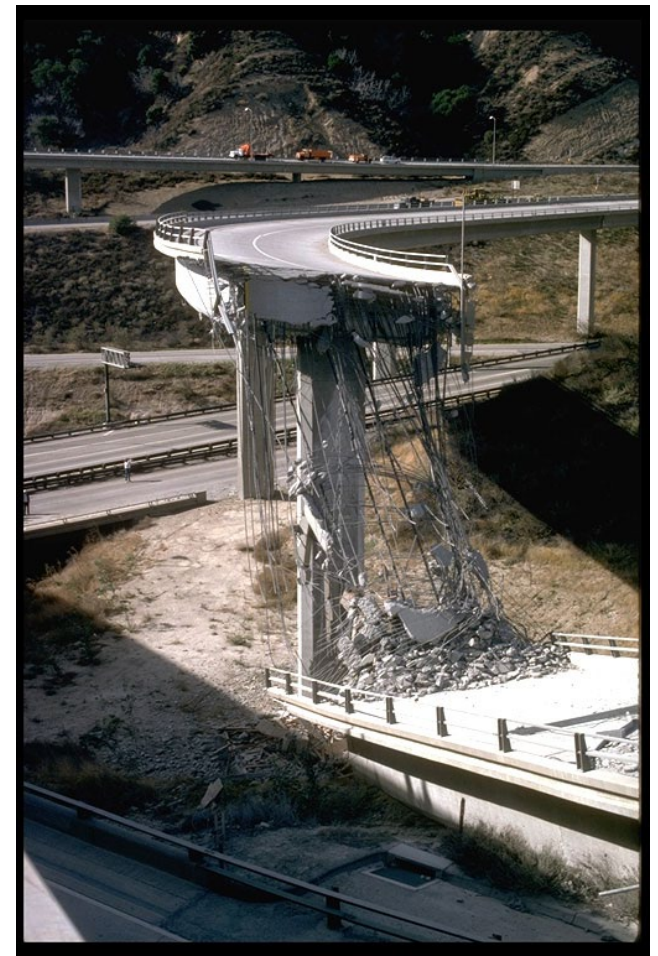
This overpass had previously collapsed during the 1971 San Fernando Valley quake and demonstrated the problems with some early highway retrofitting measures. These were later improved after the 1994 quake.

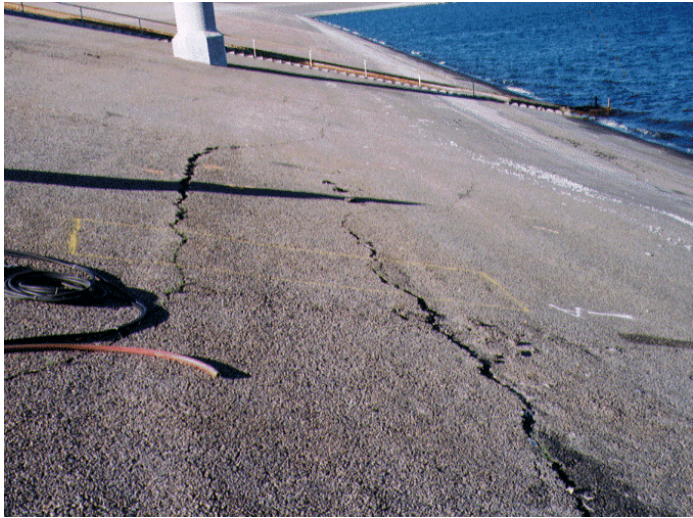
Surface cracks from 1994 quake

In contrast, the 1994 Northridge earthquake produced only minor cracks on the surface of the retrofitted dam (far left photo). Dam retrofit measures since 1971 included installation of at least 1,100 gravel columns, placed as conduits for ground water in an effort to reduce ground liquefaction and dam failure.

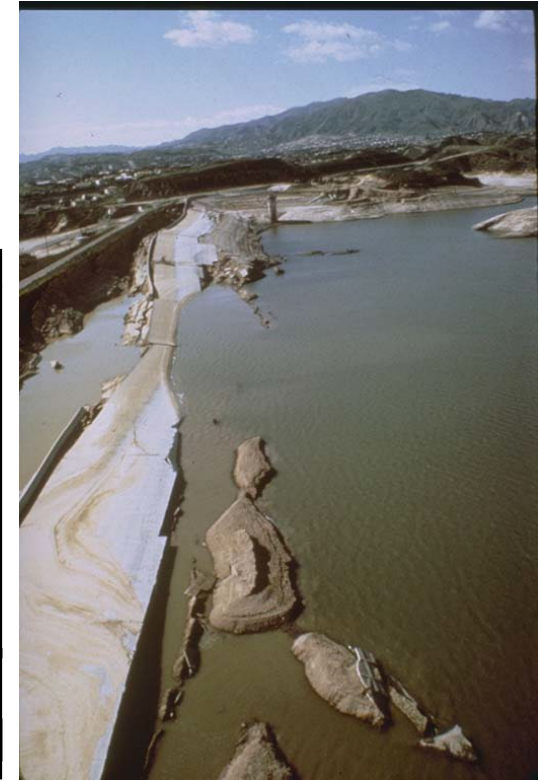
Dam failure from 1971 quake

The Los Angeles dam complex sustained major damage in the 1971 San Fernando earthquake (far right photo). As a result of this near catastrophic event all dams in California were reevaluated and retrofitted.

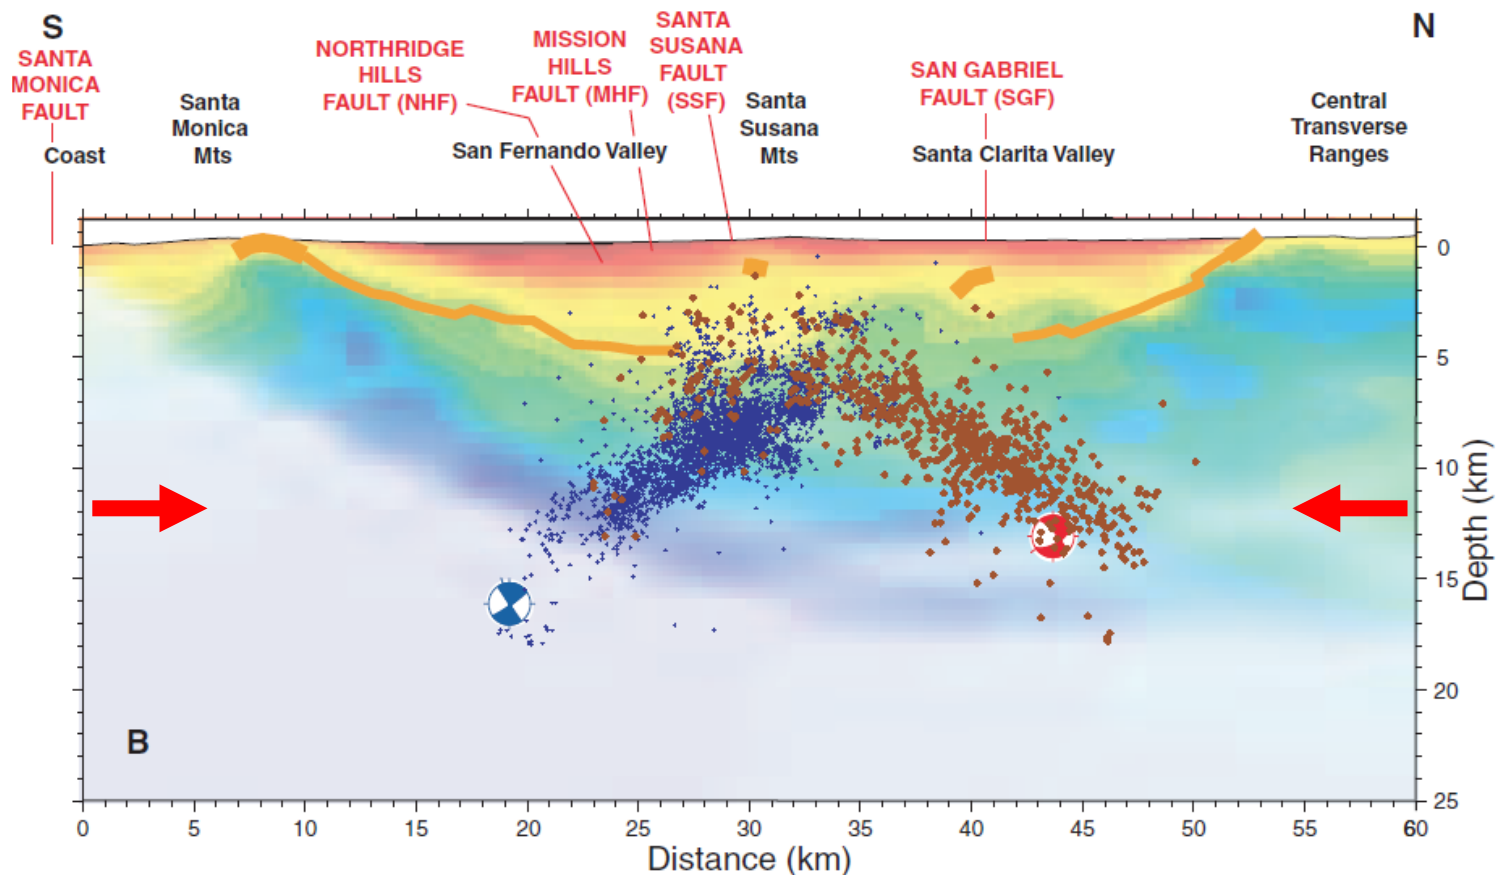
Figure from Fuis et al. (2003)

The image below is from a scientific paper that compares the aftershocks from the 1971 San Fernando Valley quake (red dots) with aftershocks from the 1994 Northridge quake (blue dots). The focal mechanisms for both quakes are also plotted at their respective hypocenters (1971 in red, 1994 in blue). This view provides a clear sense of the north-south compression in the crust (red arrows) that generated both of these earthquakes.
